# Access Compliance Report Public Rights-of-Way (Curb Ramps)

Main Street: N/A Cross Street: ETHEREAL\_RD Location: W

ADA ID: RPRK211104123114 Ramp Type: Type 4 - Parallel Initial Pass/Fail: Fail Overall Compliance: No Severity Score: 16

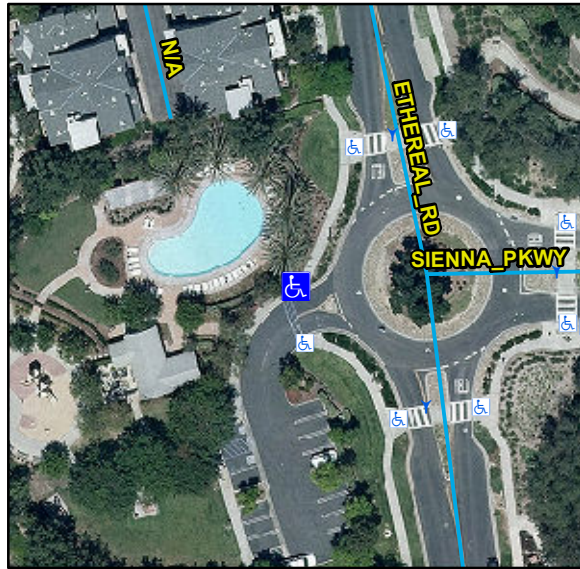
| Compliance | Description | Data | Compliance | Description | Data |
|---|---|---|---|---|---|
| No | Ramp Run Slope LT (%) | 10.7 | Yes | Ramp Run Slope RT (%) | 3.5 |
| No | Ramp Cross Slope LT (%) | 4 | No | Ramp Cross Slope RT (%) | 4.3 |

Remove & Replace Entire Ramp. Restripe Crosswalk.

R204.3, R304.3.2, R304.5.3, STD 1115
