# Access Compliance Report Public Rights-of-Way (Curb Ramps)

Main Street: ETHEREAL\_RD Cross Street: SIENNA\_PKWY Location: N

ADA ID: RPRK211104123254 Ramp Type: Type 1 - Perpendicular Initial Pass/Fail: Fail Overall Compliance: No Severity Score: 2

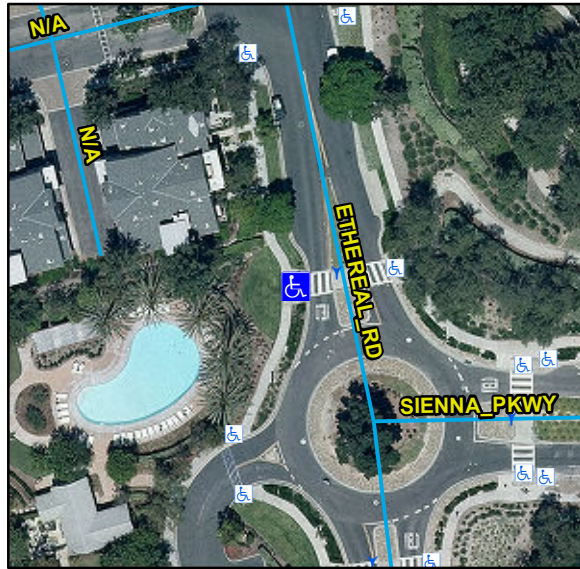
| Compliance | Description | Data | Compliance | Description | Data |
|---|---|---|---|---|---|
| No | Ramp Cross Slope (%) | 2.4 | N/A | Flare Traversable LT | N/A |

Remove & Replace Entire Ramp.

R204.3, R304.5.3, STD 1115
