# Access Compliance Report Public Rights-of-Way (Curb Ramps)

Main Street: ETHEREAL\_RD Cross Street: N/A Location: SW

ADA ID: RPRK211104123559 Ramp Type: Type 4 - Parallel Initial Pass/Fail: Fail Overall Compliance: No Severity Score: 16

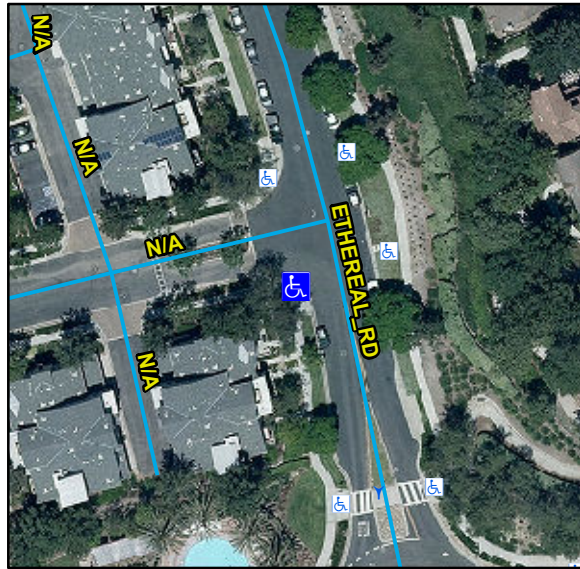
| Compliance | Description | Data | Compliance | Description | Data |
|---|---|---|---|---|---|
| Yes | Ramp Run Slope LT (%) | 2.5 | No | Ramp Run Slope RT (%) | 9 |
| No | Ramp Cross Slope LT (%) | 3.6 | No | Ramp Cross Slope RT (%) | 2.4 |

Remove & Replace Curb Ramp With Two New Directional Ramps or Equivalent.

R204.3, R304.5.3, R304.3.2, STD 1115
