# Access Compliance Report Public Rights-of-Way (Curb Ramps)

Main Street: N/A Cross Street: ETHEREAL\_RD Location: NW

ADA ID: RPRK211104123818 Ramp Type: Type 4 - Parallel Initial Pass/Fail: Fail Overall Compliance: No Severity Score: 2

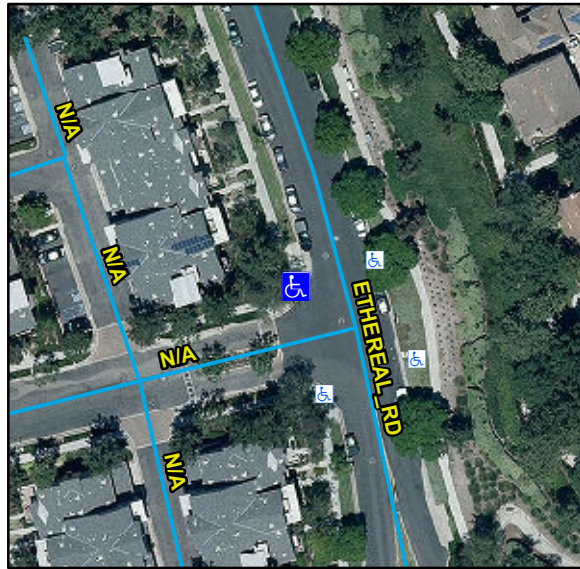
| Compliance | Description | Data | Compliance | Description | Data |
|---|---|---|---|---|---|
| No | Ramp Cross Slope LT (%) | 2.2 | No | Ramp Cross Slope RT (%) | 3.7 |
| N/A | Gutter Cross Slope (%) | N/A | No | Perpendicular Joint Present | No |

Remove & Replace Curb Ramp With Two New Directional Ramps or Equivalent.

R204.3, R304.5.3, STD 1115
