# Access Compliance Report Public Rights-of-Way (Curb Ramps)

Main Street: ETHEREAL\_RD Cross Street: SOL\_ST Location: S

ADA ID: RPRK211104124058 Ramp Type: Type 1 - Perpendicular Initial Pass/Fail: Pass Overall Compliance: No Severity Score: 15

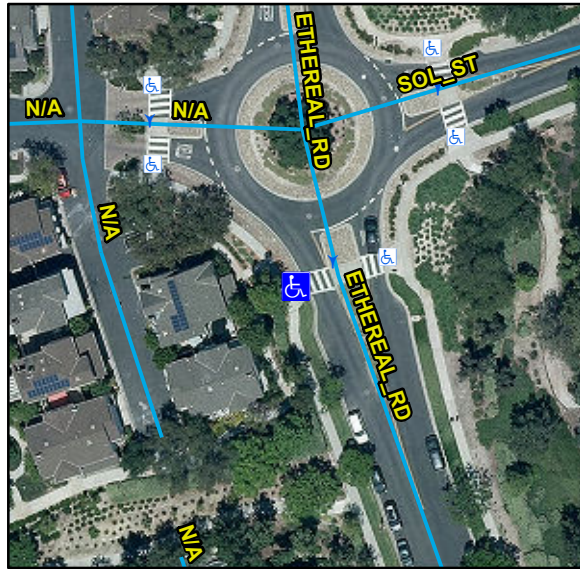
| Compliance | Description | Data | Compliance | Description | Data |
|---|---|---|---|---|---|
| Yes | Landing Cross Slope (%) | 1.9 | No | DWS Provided | No |
| Yes | Gutter Ponding | No | No | Curb Slope | 13.9 |
| No | Gutter Run Slope (%) | 7.4 | | Road Cross Slope (%) | N/A |

Remove & Replace Entire Ramp. Remove & Replace Gutter.

R304.2.2, R305, R304.5.4, STD 1115
