# Access Compliance Report Public Rights-of-Way (Curb Ramps)

Main Street: N/A Cross Street: ETHEREAL\_RD Location: W

ADA ID: RPRK211104124332 Ramp Type: Type 1 - Perpendicular Initial Pass/Fail: Fail Overall Compliance: No Severity Score: 15

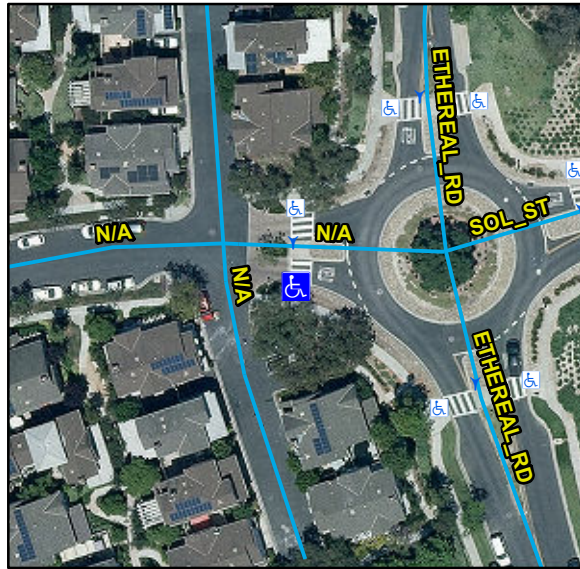
| Compliance | Description | Data | Compliance | Description | Data |
|---|---|---|---|---|---|
| No | Ramp Run Slope (%) | 8.7 | N/A | Flare Slope LT (%) | N/A |
| N/A | Gutter Ponding | N/A | No | Curb Slope | 11.6 |

Remove & Replace Entire Ramp.

R304.2.2, R204.3, STD 1115
