# Access Compliance Report Public Rights-of-Way (Curb Ramps)

Main Street: ETHEREAL\_RD Cross Street: N/A Location: W

ADA ID: RPRK211104124639 Ramp Type: Type 1 - Perpendicular Initial Pass/Fail: Pass Overall Compliance: No Severity Score: 17

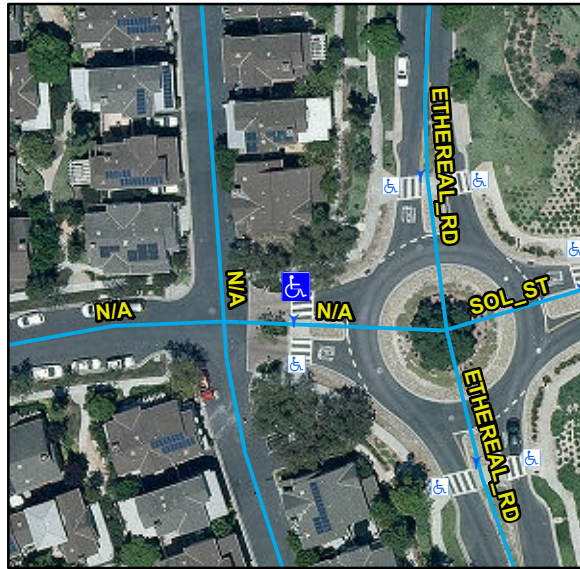
| Compliance | Description | Data | Compliance | Description | Data |
|---|---|---|---|---|---|
| No | Landing Cross Slope (%) | 2.8 | No | DWS Provided | No |
| Yes | Gutter Ponding | No | No | Curb Slope | 13.7 |
| No | Gutter Run Slope (%) | 5.8 | | Road Cross Slope (%) | N/A |

Remove & Replace Entire Ramp. Remove & Replace Gutter.

R304.2.2, R304.5.3, R305, R304.5.4, STD 1115
