# Access Compliance Report Public Rights-of-Way (Curb Ramps)

Main Street: ETHEREAL\_RD Cross Street: SOL\_ST Location: N

ADA ID: RPRK211104124823 Ramp Type: Type 1 - Perpendicular Initial Pass/Fail: Fail Overall Compliance: No Severity Score: 30

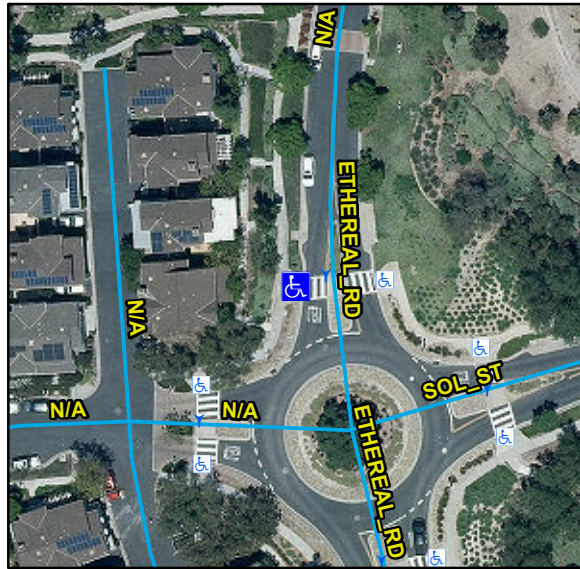
| Compliance | Description | Data | Compliance | Description | Data |
|---|---|---|---|---|---|
| No | Ramp Run Slope (%) | 11.3 | N/A | Flare Slope LT (%) | N/A |
| No | Ramp Cross Slope (%) | 5.3 | N/A | Flare Traversable LT | N/A |

Remove & Replace Entire Ramp.
