# Access Compliance Report Public Rights-of-Way (Curb Ramps)

Main Street: ETHEREAL\_RD Cross Street: SOL\_ST Location: N

ADA ID: RPRK211104125107 Ramp Type: Type 1 - Perpendicular Initial Pass/Fail: Fail Overall Compliance: No Severity Score: 2

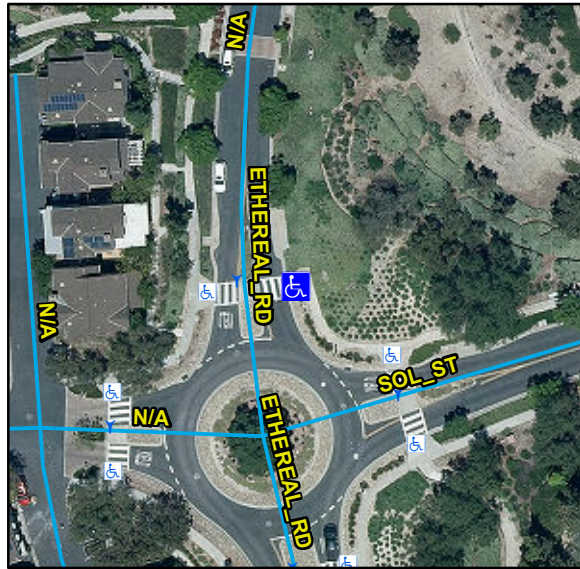
| Compliance | Description | Data | Compliance | Description | Data |
|---|---|---|---|---|---|
| No | Ramp Cross Slope (%) | 3.7 | N/A | Flare Traversable LT | N/A |
| N/A | Gutter Ponding | N/A | No | Curb Slope | 16.7 |

Remove & Replace Entire Ramp.

R304.2.2, R204.3, R304.5.3, STD 1115
