Access Compliance Report Public Rights-of-Way (Curb Ramps)

Main Street: SOL_ST **Cross Street:** ETHEREAL_RD **Location:** E

ADA ID: RPRK211104125211 **Ramp Type:**Type 1 - Perpendicular **Initial Pass/Fail:** Fail **Overall Compliance:** No **Severity Score:** 15

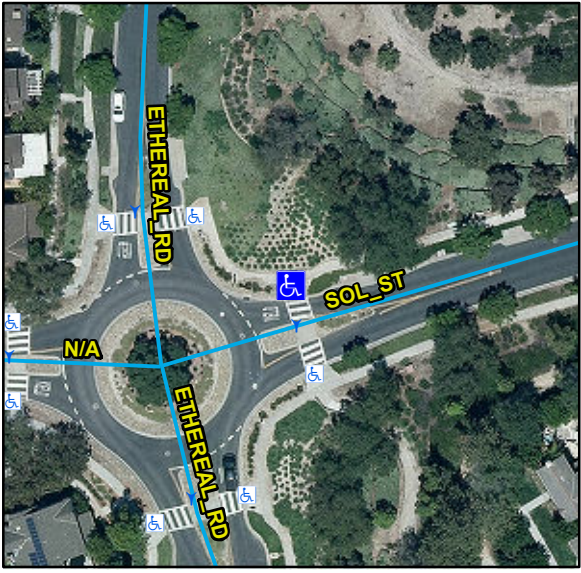
Compliance	Description	Data	Compliance	Description	Data
N/A	Ramp Length (in)	118	N/A	Flare Type LT	
Yes	Ramp Width (in)	48			N/A
No	Ramp Run Slope (%)	8.4	N/A	Flare Slope LT (%)	N/A
Yes	Ramp Cross Slope (%)	1.2	N/A	Flare Traversable LT	N/A
N/A	Landing Present	N/A	N/A	Flare Type RT	
N/A	Landing Length (in)	N/A			N/A
N/A	Landing Width (in)	N/A	N/A	Flare Slope RT (%)	N/A
N/A	Landing Run Slope (%)	N/A	N/A	Flare Traversable RT	N/A
N/A	Landing Cross Slope (%)	N/A	N/A	DWS Provided	N/A
N/A	Landing Movement Obstructed?	N/A	N/A	DWS Contrast	N/A
	Landing Movement Type	N/A	N/A	DWS Length (in)	N/A
N/A	Landing Shared	N/A	N/A	DWS Full Width	N/A
N/A	Clear Space	N/A	N/A	DWS Offset Left (in)	N/A
N/A	Clear Space To Crosswalk (in)	N/A	N/A	DWS Offset Right (in)	N/A
N/A	Marked Crosswalk 1	Yes	N/A	Marked Crosswalk 2	N/A
	Crossing 1 Direction	S		Crossing 2 Direction	N/A
	Marked Crosswalk 1 Width (in)	144		Marked Crosswalk 2 Width (in)	N/A

N/A	Ramp Inside Crosswalk 1	Yes	Yes	Ramp Inside Crosswalk 2	N/A
	Crossing 1 Slope (%)	4.2		Crossing 2 Slope (%)	N/A
	Crossing 1 Cross Slope (%)	3.7		Crossing 2 Cross Slope (%)	N/A
N/A	Gutter Ponding	N/A	No	Curb Slope	7.3
Yes	Gutter Lip Height (in)	0		Road Run Slope (%)	N/A
N/A	Gutter Run Slope (%)	N/A		Road Cross Slope (%)	N/A
N/A	Gutter Cross Slope (%)	N/A			
Yes	Overall Surface Condition: Acceptable		No	Perp Joint Present	No
	Cross Gutter Present?	No		Spandrel Present?	No
	Replace Cross Gutter?	N/A		Replace Spandrel?	N/A

Possible Solutions:
Remove & Replace Entire Ramp.

OC Std/PROW:
R304.2.2, R204.3, STD 1115
