# Access Compliance Report Public Rights-of-Way (Curb Ramps)

| Main Street: SOL_ST | | Cross Street: ETHEREAL_RD | | Location: | E |
| ADA ID: RPRK211104125519 | Ramp Type:Type 1 - Perpendicular | Initial Pass/Fail: Fail | Overall Compliance: No | Severity Score: | 15 |

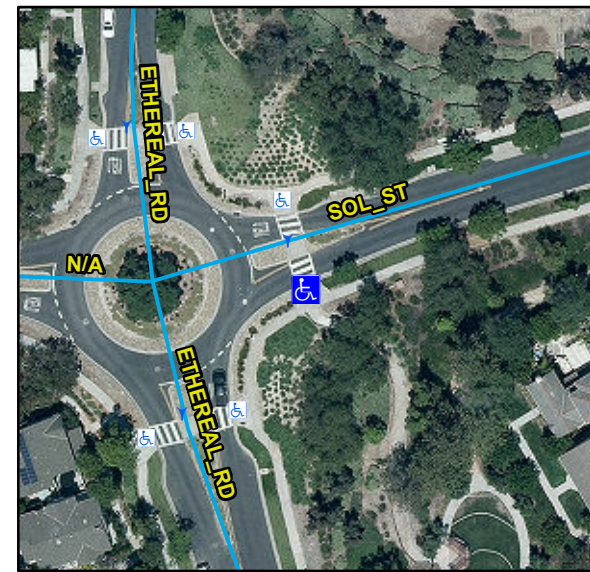
R304.2.2, R204.3, STD 1115

| Compliance | Description | Data | Compliance | Description | Data |
|---|---|---|---|---|---|
| No | Ramp Run Slope (%) | 9.2 | N/A | Flare Slope LT (%) | N/A |

Remove & Replace Entire Ramp.

Total Cost: \$ 3080
