# Access Compliance Report Public Rights-of-Way (Curb Ramps)

Main Street: N/A Cross Street: SOL\_ST Location: S

ADA ID: RPRK211104125848 Ramp Type: Type 4 - Parallel Initial Pass/Fail: Pass Overall Compliance: No Severity Score: 20

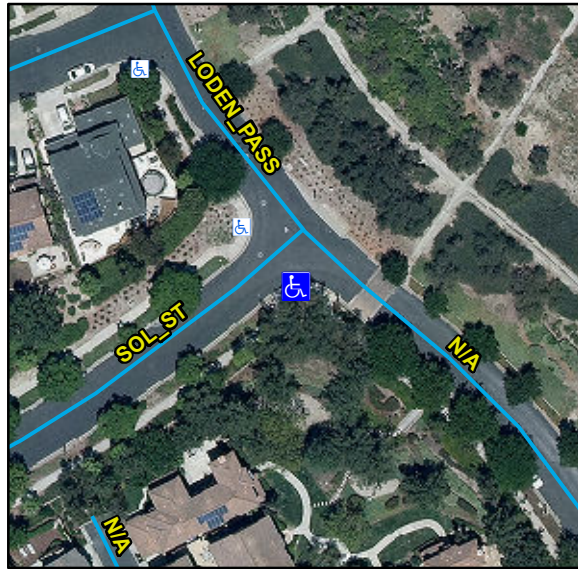
| Compliance | Description | Data | Compliance | Description | Data |
|---|---|---|---|---|---|
| N/A | Landing Present | No | No | DWS Provided | No |
| Yes | Gutter Ponding | No | No | Curb Slope | 11 |
| No | Gutter Cross Slope (%) | 3.2 | No | Perpendicular Joint Present | No |

Remove & Replace Curb Ramp With Two New Directional Ramps or Equivalent. Remove & Replace Gutter.

Total Cost: \$ 4252
