# Access Compliance Report Public Rights-of-Way (Curb Ramps)

Main Street: LODEN\_PASS Cross Street: SUGARCANE\_LN Location: W

ADA ID: RPRK211104131531 Ramp Type: Type 4 - Parallel Initial Pass/Fail: Pass Overall Compliance: No Severity Score: 26

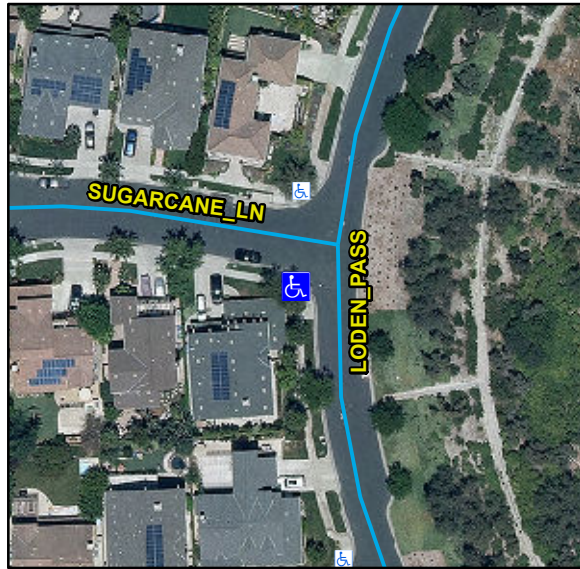
| Compliance | Description | Data | Compliance | Description | Data |
|---|---|---|---|---|---|
| N/A | Landing Present | No | No | DWS Provided | No |
| No | Landing Width (in) | N/A | N/A | DWS Length (in) | N/A |
| No | Landing Run Slope (%) | N/A | N/A | DWS Full Width | N/A |
| No | Landing Cross Slope (%) | N/A | | DWS Offset Type | N/A |
| No | Gutter Ponding | Yes | Yes | Curb Slope | 2.5 |
| No | Gutter Run Slope (%) | 8.1 | | Road Cross Slope (%) | 1.8 |

Remove & Replace Curb Ramp With Two New Directional Ramps or Equivalent. Remove & Replace Gutter.
