# Access Compliance Report Public Rights-of-Way (Curb Ramps)

Main Street: PATINA\_LN Cross Street: LODEN\_PASS Location: NW

ADA ID: RPRK211104131750 Ramp Type: Type 4 - Parallel Initial Pass/Fail: Fail Overall Compliance: No Severity Score: 30

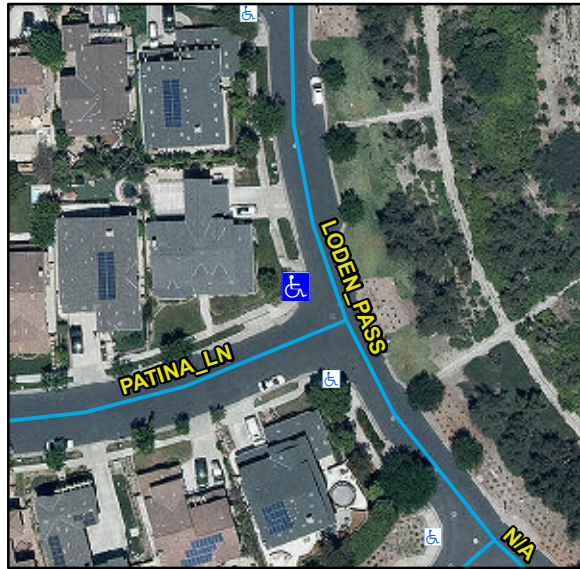
R204.3, R304.5.3, R304.3.2, STD 1115

| Compliance | Description | Data | Compliance | Description | Data |
|---|---|---|---|---|---|
| Yes | Ramp Run Slope LT (%) | 1.1 | No | Ramp Run Slope RT (%) | 9.1 |
| No | Ramp Cross Slope LT (%) | 3.7 | No | Ramp Cross Slope RT (%) | 5.2 |

Remove & Replace Curb Ramp With Two New Directional Ramps or Equivalent.
