# Access Compliance Report Public Rights-of-Way (Curb Ramps)

Main Street: LODEN\_PASS Cross Street: PATINA\_LN Location: SW

ADA ID: RPRK211104132010 Ramp Type: Type 4 - Parallel Initial Pass/Fail: Fail Overall Compliance: No Severity Score: 2

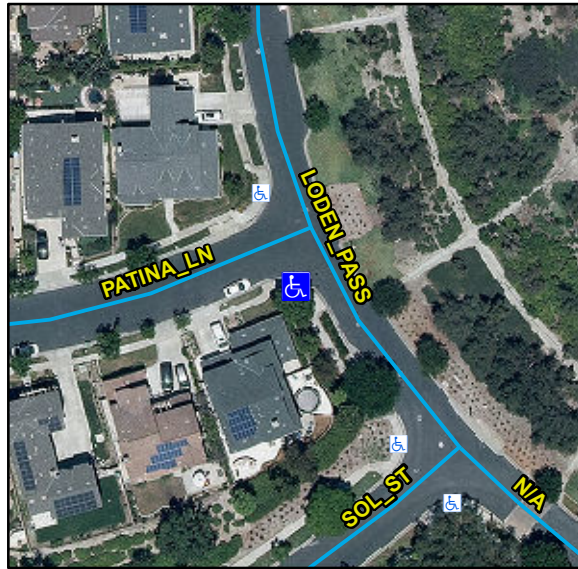
| Compliance | Description | Data | Compliance | Description | Data |
|---|---|---|---|---|---|
| No | Ramp Cross Slope LT (%) | 2.5 | Yes | Ramp Cross Slope RT (%) | 1.9 |

Remove & Replace Curb Ramp With Two New Directional Ramps or Equivalent.
