# Access Compliance Report Public Rights-of-Way (Curb Ramps)

Main Street: SOL\_ST Cross Street: LODEN\_PASS Location: NW

ADA ID: RPRK211104132205 Ramp Type: Type 4 - Parallel Initial Pass/Fail: Fail Overall Compliance: No Severity Score: 15

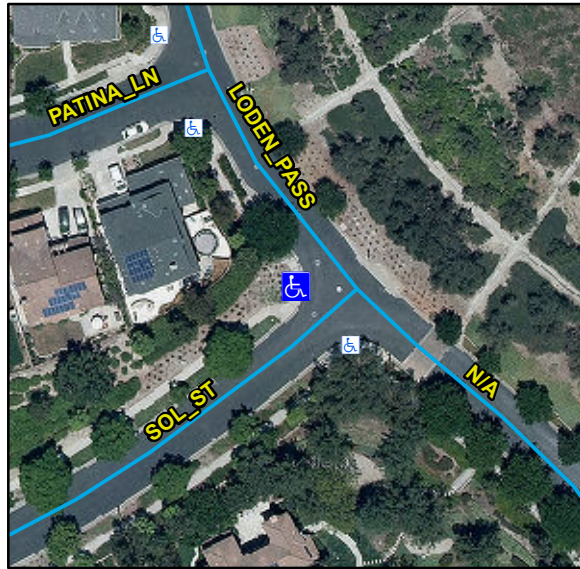
| Compliance | Description | Data | Compliance | Description | Data |
|---|---|---|---|---|---|
| Yes | Ramp Run Slope LT (%) | 1.2 | No | Ramp Run Slope RT (%) | 11.6 |

Remove & Replace Curb Ramp With Two New Directional Ramps or Equivalent.

R304.3.2, STD 1115
