# Access Compliance Report Public Rights-of-Way (Curb Ramps)

Main Street: ETHEREAL\_RD Cross Street: SOL\_ST Location: S

ADA ID: RPRK211104132425 Ramp Type: Type 1 - Perpendicular Initial Pass/Fail: Fail Overall Compliance: No Severity Score: 30

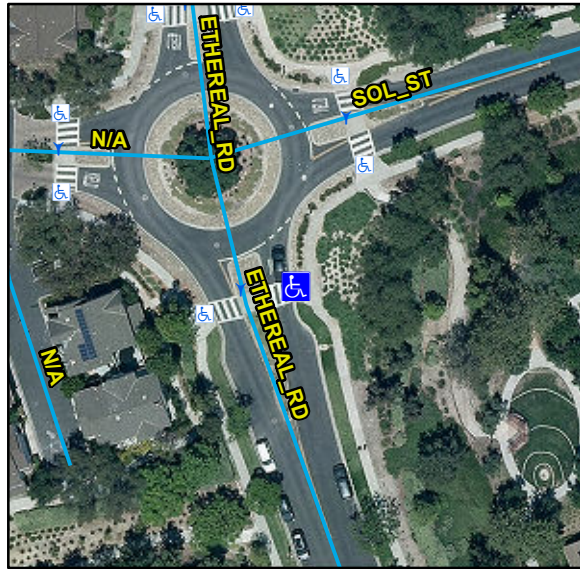
| Compliance | Description | Data | Compliance | Description | Data |
|---|---|---|---|---|---|
| No | Ramp Run Slope (%) | 12.3 | N/A | Flare Slope LT (%) | N/A |

Remove & Replace Entire Ramp.

R204.3, R304.2.2, STD 1115
