# Access Compliance Report Public Rights-of-Way (Curb Ramps)

| Main Street: FLINTRIDGE_AVE | | Cross Street: TISBURY_WAY | | Location: | N |
| ADA ID: RPRK211104133919 | Ramp Type:Type 1 - Perpendicular | Initial Pass/Fail: Fail | Overall Compliance: No | Severity Score: | 30 |

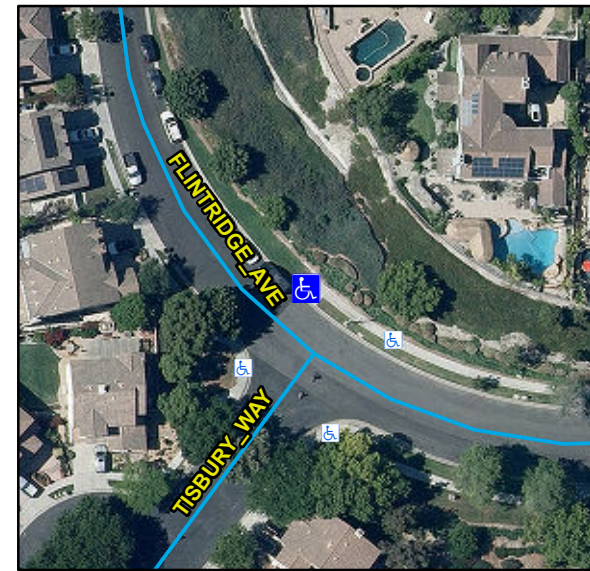
| Compliance | Description | Data | Compliance | Description | Data |
|---|---|---|---|---|---|
| No | Ramp Run Slope (%) | 12 | N/A | Flare Slope LT (%) | N/A |
| No | Ramp Cross Slope (%) | 5.8 | N/A | Flare Traversable LT | N/A |

**Remove & Replace Entire Ramp.**

**R204.3, R304.2.2, R304.5.3, STD 1115**
