# Access Compliance Report Public Rights-of-Way (Curb Ramps)

| Main Street: FLINTRIDGE_AVE | | Cross Street: TISBURY_WAY | | Location: | S |
| ADA ID: RPRK211104134102 | Ramp Type: Type 4 - Parallel | Initial Pass/Fail: Fail | Overall Compliance: No | Severity Score: | 30 |

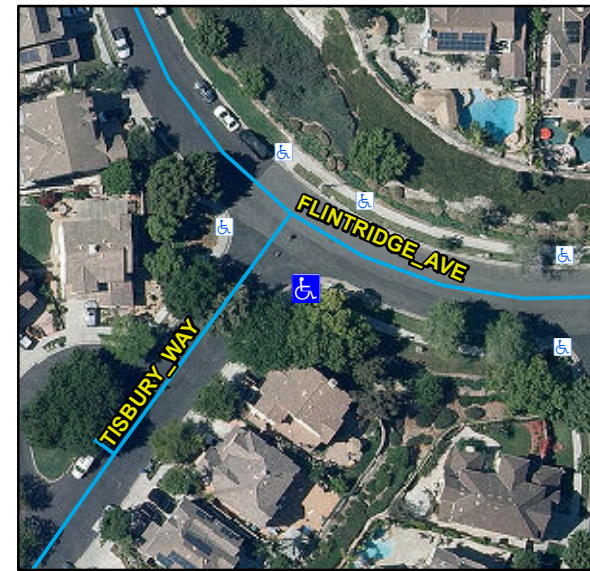
| Compliance | Description | Data | Compliance | Description | Data |
|---|---|---|---|---|---|
| No | Ramp Run Slope LT (%) | 15.1 | Yes | Ramp Run Slope RT (%) | 1.1 |

Possible Solutions:

**Remove & Replace Curb Ramp With Two New Directional Ramps or Equivalent.**

**R204.3, R304.3.2, STD 1115**

Total Cost: \$ 4000
