# Access Compliance Report Public Rights-of-Way (Curb Ramps)

| Main Street: TISBURY_WAY | | Cross Street: FLINTRIDGE_AVE | | Location: | W |
| ADA ID: RPRK211104134254 | Ramp Type: Type 4 - Parallel | Initial Pass/Fail: Fail | Overall Compliance: No | Severity Score: | 16 |

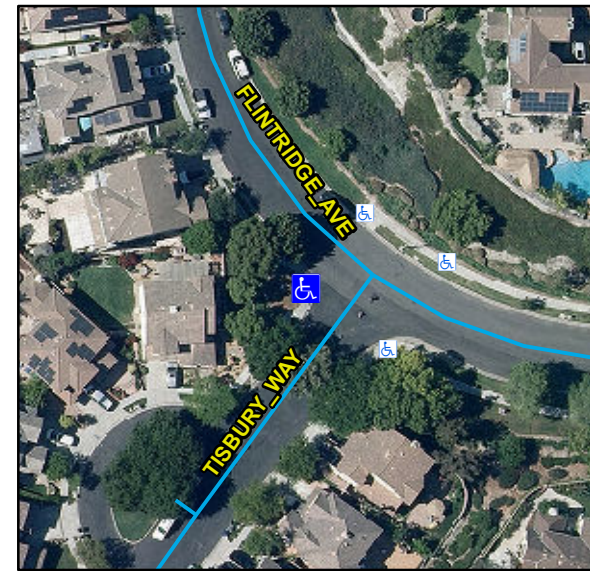
| Compliance | Description | Data | Compliance | Description | Data |
|---|---|---|---|---|---|
| No | Ramp Run Slope LT (%) | 8.5 | Yes | Ramp Run Slope RT (%) | 1.7 |
| Yes | Ramp Cross Slope LT (%) | 1.2 | No | Ramp Cross Slope RT (%) | 2.1 |

**Remove & Replace Curb Ramp With Two New Directional Ramps or Equivalent.**

**R204.3, R304.3.2, R304.5.3, STD 1115**

Total Cost: \$ 4000
