# Access Compliance Report Public Rights-of-Way (Curb Ramps)

| Main Street: FLINTRIDGE_AVE | | Cross Street: FLINTRIDGE_AVE | | Location: | NW |
| ADA ID: RPRK211104134527 | Ramp Type:Type 1 - Perpendicular | Initial Pass/Fail: Fail | Overall Compliance: No | Severity Score: | 30 |

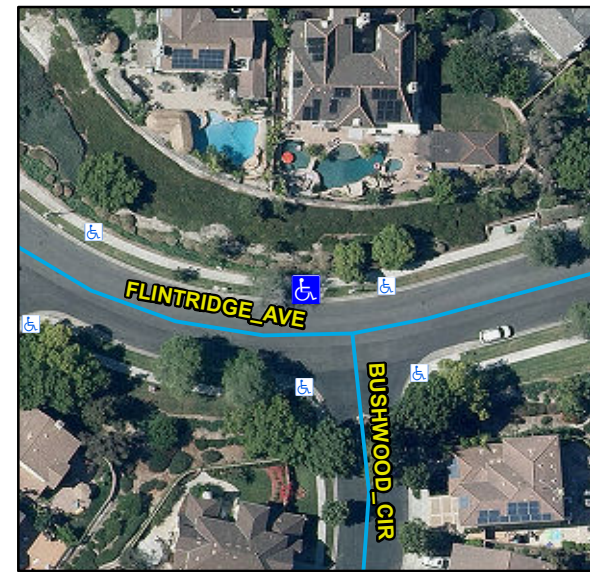
R304.2.2, R204.3, R304.5.3, STD 1115

| Compliance | Description | Data | Compliance | Description | Data |
|---|---|---|---|---|---|
| No | Ramp Run Slope (%) | 10.3 | N/A | Flare Slope LT (%) | N/A |
| No | Ramp Cross Slope (%) | 6.3 | N/A | Flare Traversable LT | N/A |

Remove & Replace Entire Ramp.

Total Cost: \$ 3080
