# Access Compliance Report Public Rights-of-Way (Curb Ramps)

Main Street: FLINTRIDGE\_AVE Cross Street: BUSHWOOD\_CIR Location: SE

ADA ID: RPRK211104134658 Ramp Type: Type 4 - Parallel Initial Pass/Fail: Fail Overall Compliance: No Severity Score: 32

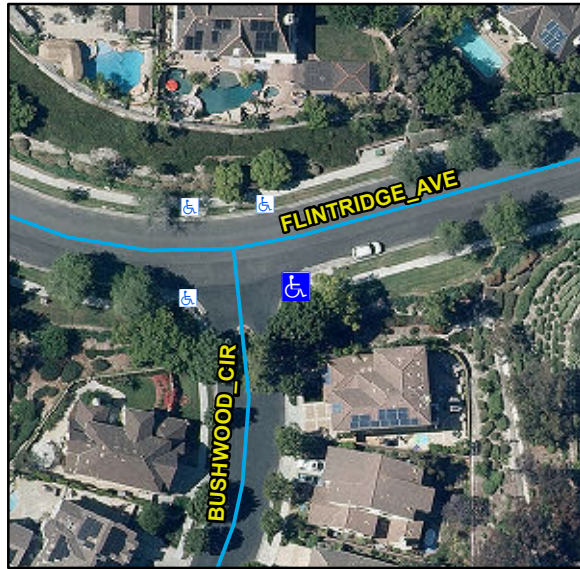
| Compliance | Description | Data | Compliance | Description | Data |
|---|---|---|---|---|---|
| No | Ramp Run Slope LT (%) | 13.4 | Yes | Ramp Run Slope RT (%) | 2 |
| No | Ramp Cross Slope LT (%) | 2.4 | No | Ramp Cross Slope RT (%) | 2.8 |

Remove & Replace Curb Ramp With Two New Directional Ramps or Equivalent.

R204.3, R304.3.2, R304.5.3, STD 1115
