# Access Compliance Report Public Rights-of-Way (Curb Ramps)

Main Street: BUSHWOOD\_CIR Cross Street: FLINTRIDGE\_AVE Location: SW

ADA ID: RPRK211104134835 Ramp Type: Type 4 - Parallel Initial Pass/Fail: Pass Overall Compliance: No Severity Score: 25

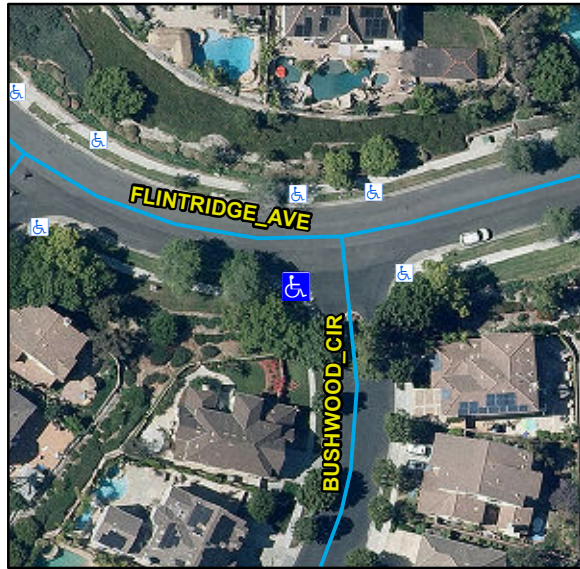
| Compliance | Description | Data | Compliance | Description | Data |
|---|---|---|---|---|---|
| No | Landing Width (in) | N/A | N/A | DWS Length (in) | N/A |
| No | Landing Run Slope (%) | N/A | N/A | DWS Full Width | N/A |
| No | Landing Cross Slope (%) | N/A | | DWS Offset Type | N/A |
| No | Gutter Run Slope (%) | 10.5 | | Road Cross Slope (%) | 9.5 |
| No | Gutter Cross Slope (%) | 2.1 | No | Perpendicular Joint Present | No |

**Remove & Replace Curb Ramp With Two New Directional Ramps or Equivalent. Remove & Replace Gutter.**
