# Access Compliance Report Public Rights-of-Way (Curb Ramps)

Main Street: BUSHWOOD\_CIR Cross Street: BEACH\_POINT Location: SW

ADA ID: RPRK211104135414 Ramp Type: Type 4 - Parallel Initial Pass/Fail: Fail Overall Compliance: No Severity Score: 2

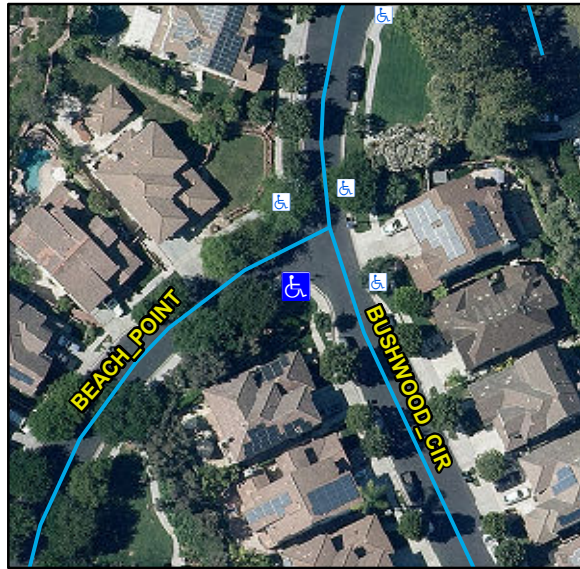
| Compliance | Description | Data | Compliance | Description | Data |
|---|---|---|---|---|---|
| No | Obstructions Present? | Yes | N/A | Utilities Present? | No |
| | Obstruction Types | Basketball Hoop | | Utility Types | |

| Compliance | Description | Data | Compliance | Description | Data |
|---|---|---|---|---|---|
| No | Ramp Cross Slope LT (%) | 2.2 | No | Ramp Cross Slope RT (%) | 2.1 |

**Remove & Replace Curb Ramp With Two New Directional Ramps or Equivalent.**
