# Access Compliance Report Public Rights-of-Way (Curb Ramps)

Main Street: WEGEFORD\_RD Cross Street: BUSHWOOD\_CIR Location: S

ADA ID: RPRK211104135722 Ramp Type: Type 4 - Parallel Initial Pass/Fail: Fail Overall Compliance: No Severity Score: 30

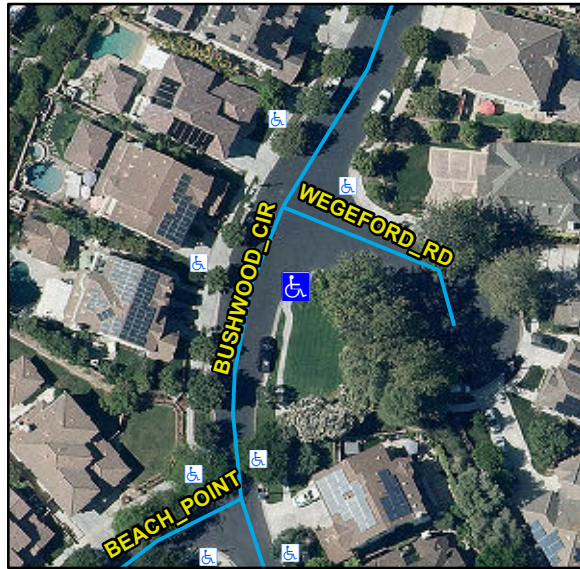
| Compliance | Description | Data | Compliance | Description | Data |
|---|---|---|---|---|---|
| No | Ramp Run Slope LT (%) | 13.3 | Yes | Ramp Run Slope RT (%) | 0.6 |

Remove & Replace Curb Ramp With Two New Directional Ramps or Equivalent.

R204.3, R304.3.2, STD 1115
