# Access Compliance Report Public Rights-of-Way (Curb Ramps)

Main Street: BUSHWOOD\_CIR Cross Street: WEGEFORD\_RD Location: E

ADA ID: RPRK211104135926 Ramp Type: Type 4 - Parallel Initial Pass/Fail: Fail Overall Compliance: No Severity Score: 16

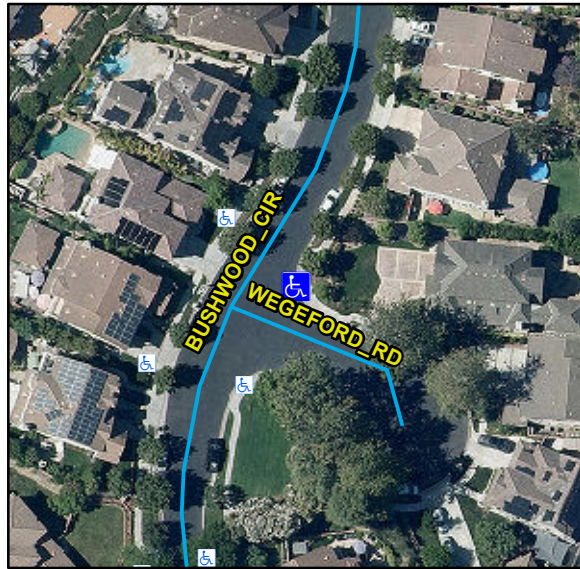
| Compliance | Description | Data | Compliance | Description | Data |
|---|---|---|---|---|---|
| No | Ramp Run Slope LT (%) | 11.7 | Yes | Ramp Run Slope RT (%) | 1.9 |
| No | Ramp Cross Slope LT (%) | 2.6 | No | Ramp Cross Slope RT (%) | 2.5 |

Remove & Replace Curb Ramp With Two New Directional Ramps or Equivalent.
