# Access Compliance Report Public Rights-of-Way (Curb Ramps)

| Main Street: FLINTRIDGE_AVE | | Cross Street: LEWISTON_CT | | Location: | SE |
| ADA ID: RPRK211104140319 | Ramp Type:Type 1 - Perpendicular | Initial Pass/Fail: Fail | Overall Compliance: No | Severity Score: | 15 |

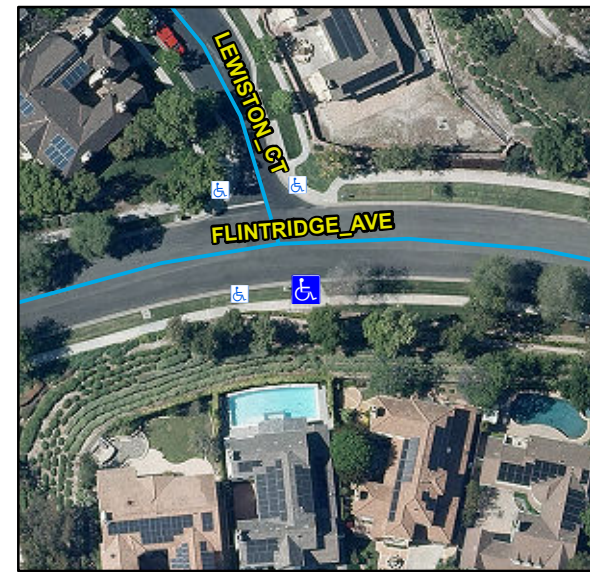
| Compliance | Description | Data | Compliance | Description | Data |
|---|---|---|---|---|---|
| No | Ramp Run Slope (%) | 9.2 | N/A | Flare Slope LT (%) | N/A |

Remove & Replace Entire Ramp.

R304.2.2, R204.3, STD 1115

Total Cost: \$ 3080
