# Access Compliance Report Public Rights-of-Way (Curb Ramps)

Main Street: LEWISTON\_CT Cross Street: FLINTRIDGE\_AVE Location: NE

ADA ID: RPRK211104140430 Ramp Type: Type 4 - Parallel Initial Pass/Fail: Fail Overall Compliance: No Severity Score: 16

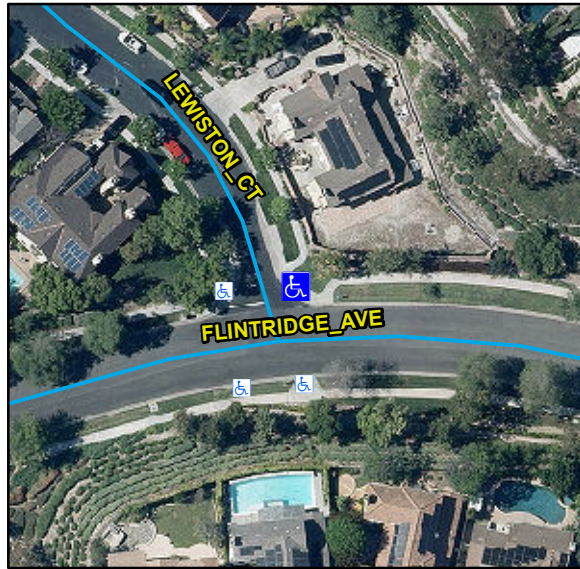
| Compliance | Description | Data | Compliance | Description | Data |
|---|---|---|---|---|---|
| Yes | Ramp Run Slope LT (%) | 3.5 | No | Ramp Run Slope RT (%) | 10.3 |
| No | Ramp Cross Slope LT (%) | 2.6 | Yes | Ramp Cross Slope RT (%) | 1.7 |

Remove & Replace Curb Ramp With Two New Directional Ramps or Equivalent.

R204.3, R304.5.3, R304.3.2, STD 1115
