# Access Compliance Report Public Rights-of-Way (Curb Ramps)

Main Street: FLINTRIDGE\_AVE Cross Street: LEWISTON\_CT Location: NW

ADA ID: RPRK211104140613 Ramp Type: Type 4 - Parallel Initial Pass/Fail: Fail Overall Compliance: No Severity Score: 16

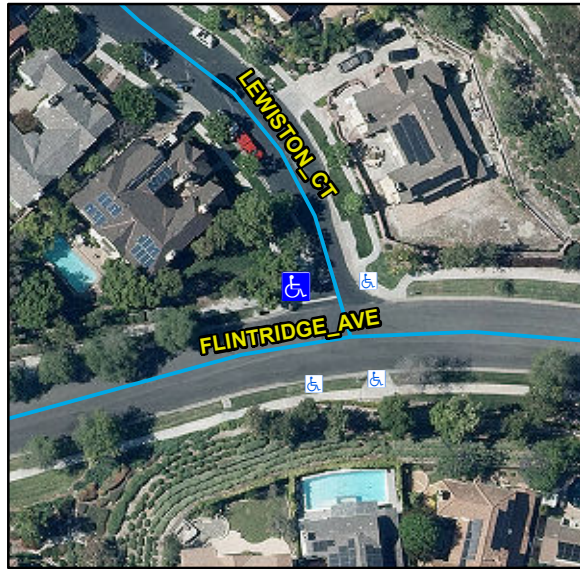
| Compliance | Description | Data | Compliance | Description | Data |
|---|---|---|---|---|---|
| Yes | Ramp Run Slope LT (%) | 3.1 | No | Ramp Run Slope RT (%) | 8.6 |
| No | Ramp Cross Slope LT (%) | 2.2 | Yes | Ramp Cross Slope RT (%) | 0.5 |

Remove & Replace Curb Ramp With Two New Directional Ramps or Equivalent.

R204.3, R304.5.3, R304.3.2, STD 1115
