# Access Compliance Report Public Rights-of-Way (Curb Ramps)

Main Street: CRESTMONT\_CT Cross Street: LEWISTON\_CT Location: NW

ADA ID: RPRK211104141122 Ramp Type: Type 4 - Parallel Initial Pass/Fail: Fail Overall Compliance: No Severity Score: 15

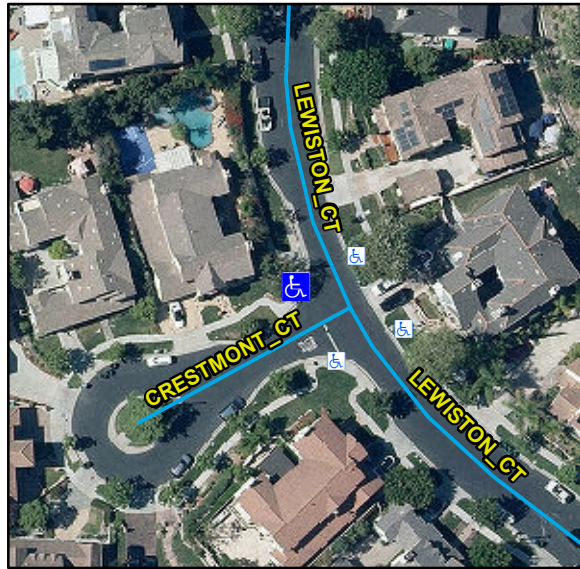
| Compliance | Description | Data | Compliance | Description | Data |
|---|---|---|---|---|---|
| Yes | Ramp Run Slope LT (%) | 1.1 | No | Ramp Run Slope RT (%) | 9.4 |

Remove & Replace Curb Ramp With Two New Directional Ramps or Equivalent.

R204.3, R304.3.2, STD 1115
