# Access Compliance Report Public Rights-of-Way (Curb Ramps)

Main Street: SIENNA\_PKWY Cross Street: SECOND\_ST Location: NE

ADA ID: RPRK211108112914 Ramp Type: Type 4 - Parallel Initial Pass/Fail: Pass Overall Compliance: No Severity Score: 10

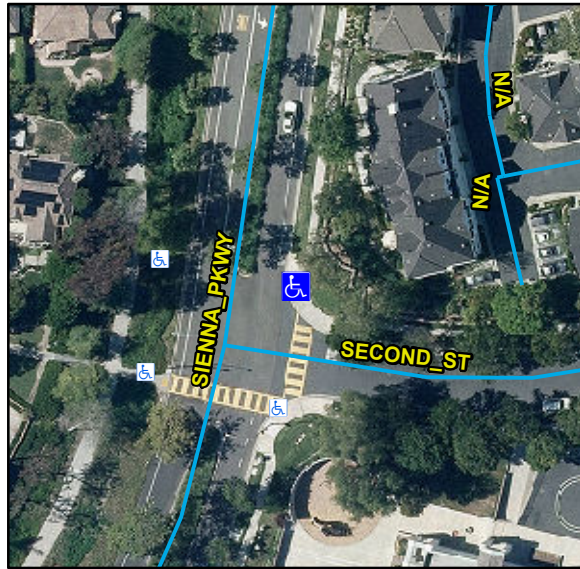
| Compliance | Description | Data | Compliance | Description | Data |
|---|---|---|---|---|---|
| N/A | Landing Present | No | Yes | DWS Provided | Yes |
| No | Landing Width (in) | N/A | Yes | DWS Length (in) | 36 |
| No | Landing Run Slope (%) | N/A | Yes | DWS Full Width | Yes |
| No | Landing Cross Slope (%) | N/A | | DWS Offset Type | Single |
| No | Gutter Cross Slope (%) | 2.2 | Yes | Perpendicular Joint Present | Yes |

Install Landing. Remove & Replace Gutter.

R304.2.1, R304.2.2-Perp, R304.3.2-Para, R304.5.3, STD 1115

Total Cost: \$ 783
