# Access Compliance Report Public Rights-of-Way (Curb Ramps)

Main Street: SECOND\_ST Cross Street: SIENNA\_PKWY Location: SE

ADA ID: RPRK211108113424 Ramp Type: Type 4 - Parallel Initial Pass/Fail: Fail Overall Compliance: No Severity Score: 2

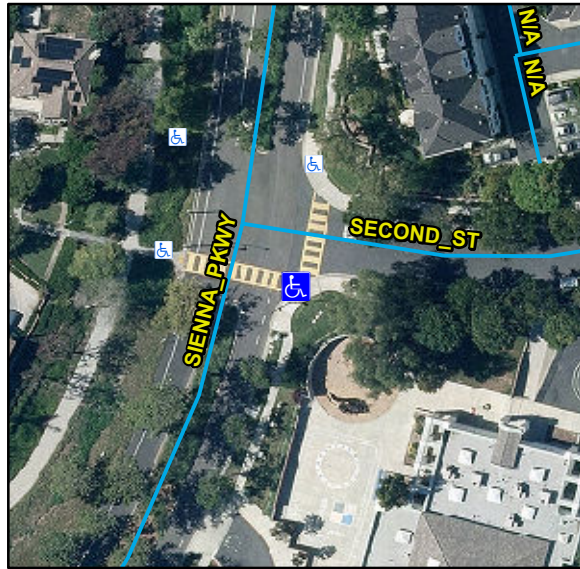
| Compliance | Description | Data | Compliance | Description | Data |
|---|---|---|---|---|---|
| No | Ramp Cross Slope LT (%) | 3.2 | No | Ramp Cross Slope RT (%) | 2.5 |

**Remove & Replace Curb Ramp With Two New Directional Ramps or Equivalent.**

**R304.5.3, STD 1115**
