# Access Compliance Report Public Rights-of-Way (Curb Ramps)

Main Street: SIENNA\_PKWY Cross Street: SECOND\_ST Location: W

ADA ID: RPRK211108113634 Ramp Type: Type 1 - Perpendicular Initial Pass/Fail: Pass Overall Compliance: No Severity Score: 6

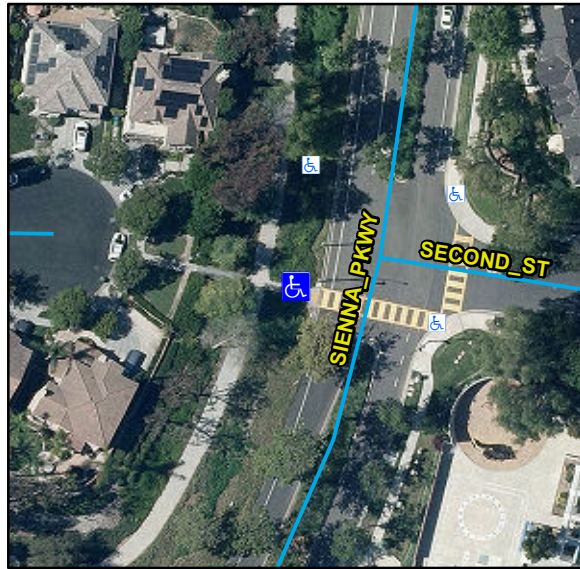
| Compliance | Description | Data | Compliance | Description | Data |
|---|---|---|---|---|---|
| No | Landing Cross Slope (%) | 3.9 | Yes | DWS Provided | Yes |
| No | Gutter Run Slope (%) | 6.1 | | Road Cross Slope (%) | N/A |
| No | Gutter Cross Slope (%) | 3.8 | | | |

Remove & Replace Entire Ramp. Remove & Replace Gutter.

R304.2.2, R204.3, R304.5.3, R304.5.4, STD 1115
