# Access Compliance Report Public Rights-of-Way (Curb Ramps)

Main Street: FLINTRIDGE\_AVE Cross Street: WELDON\_HEIGHTS Location: NE

ADA ID: RPRK211108120649 Ramp Type: Type 4 - Parallel Initial Pass/Fail: Fail Overall Compliance: No Severity Score: 2

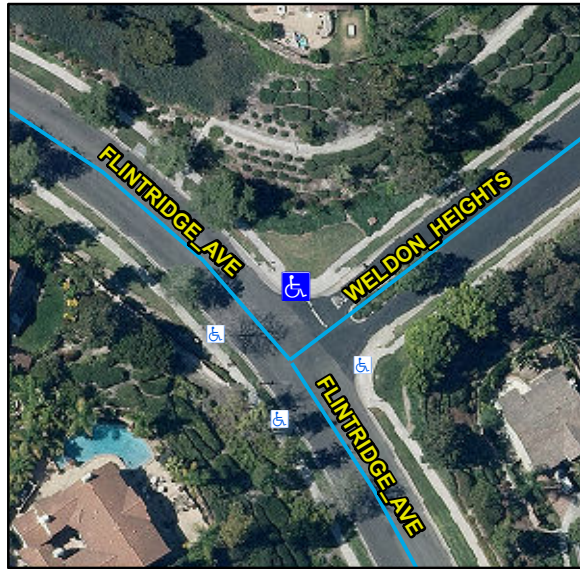
| Compliance | Description | Data | Compliance | Description | Data |
|---|---|---|---|---|---|
| No | Ramp Cross Slope LT (%) | 2.3 | No | Ramp Cross Slope RT (%) | 2.5 |

**Remove & Replace Curb Ramp With Two New Directional Ramps or Equivalent.**

**R304.5.3, STD 1115**
