# Access Compliance Report Public Rights-of-Way (Curb Ramps)

| Main Street: FLINTRIDGE_AVE | | Cross Street: WELDON_HEIGHTS | | Location: | SW |
| ADA ID: RPRK211108120959 | Ramp Type:Type 1 - Perpendicular | Initial Pass/Fail: Pass | Overall Compliance: No | Severity Score: | 16 |

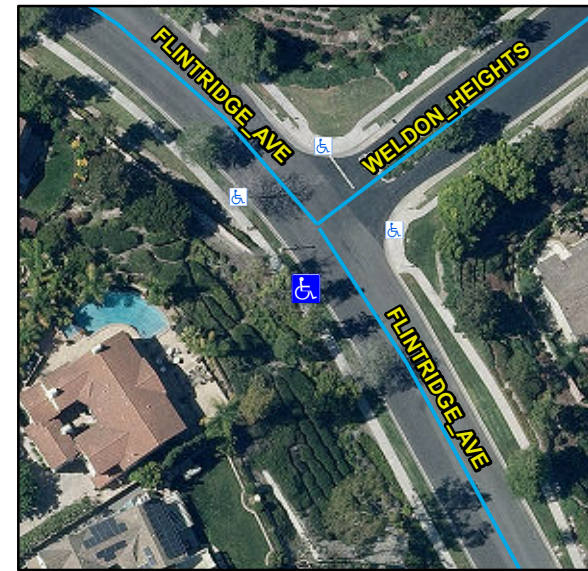
| Compliance | Description | Data | Compliance | Description | Data |
|---|---|---|---|---|---|
| No | Landing Run Slope (%) | 2.6 | N/A | Flare Traversable RT | No |
| Yes | Landing Cross Slope (%) | 1.5 | No | DWS Provided | No |
| No | Gutter Run Slope (%) | 9.1 | | Road Cross Slope (%) | N/A |
| No | Gutter Cross Slope (%) | 3.2 | | | |

Remove & Replace Entire Ramp. Remove & Replace Gutter.
