# Access Compliance Report Public Rights-of-Way (Curb Ramps)

| Main Street: WELDON_HEIGHTS | | Cross Street: FLINTRIDGE_AVE | | Location: | SE |
| ADA ID: RPRK211108121139 | Ramp Type: Type 4 - Parallel | Initial Pass/Fail: Fail | Overall Compliance: No | Severity Score: | 2 |

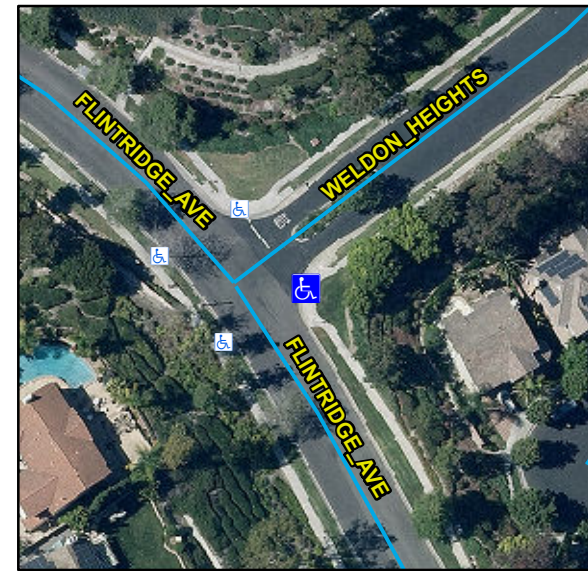
**R304.2.2, R204.3, R304.5.3, STD 1115**

**Remove & Replace Curb Ramp With Two New Directional Ramps or Equivalent.**

Total Cost: \$ 4000

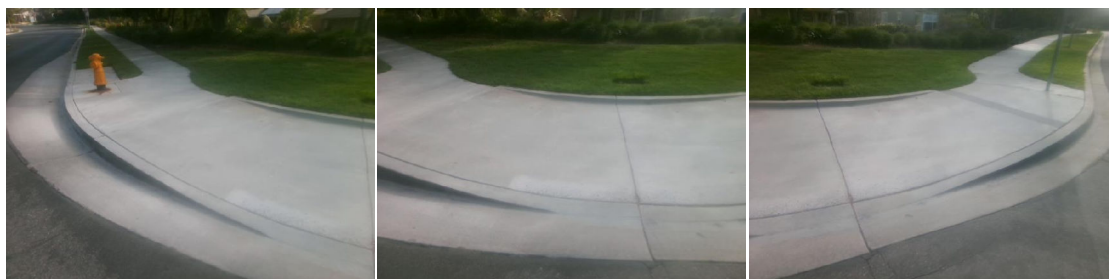
| Compliance | Description | Data | Compliance | Description | Data |
|---|---|---|---|---|---|
| Yes | Ramp Cross Slope LT (%) | 2 | No | Ramp Cross Slope RT (%) | 2.1 |
| N/A | Gutter Ponding | N/A | No | Curb Slope | 12.1 |
| N/A | Gutter Cross Slope (%) | N/A | No | Perpendicular Joint Present | No |
