# Access Compliance Report Public Rights-of-Way (Curb Ramps)

| Main Street: SIENNA_PKWY | | Cross Street: FLINTRIDGE_AVE | | Location: | E |
| ADA ID: RPRK211108122908 | Ramp Type: Type 1 - Perpendicular | Initial Pass/Fail: Fail | Overall Compliance: No | Severity Score: | 2 |

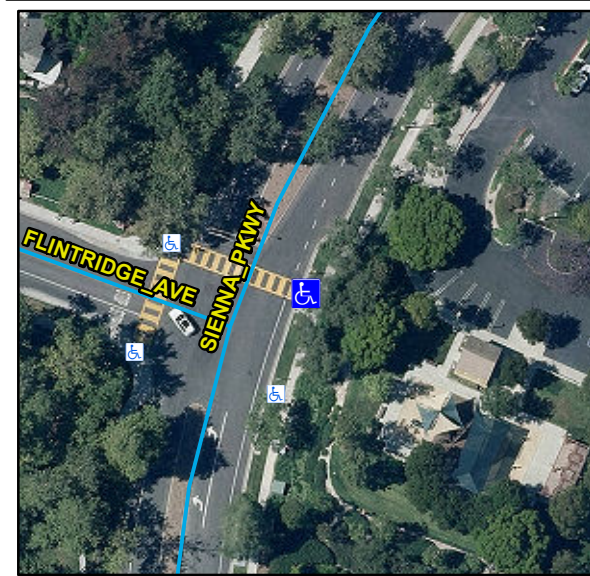
R304.2.2, R204.3, R304.5.3, STD 1115

| Compliance | Description | Data | Compliance | Description | Data |
|---|---|---|---|---|---|
| No | Ramp Cross Slope (%) | 2.9 | N/A | Flare Traversable LT | N/A |

Remove & Replace Entire Ramp.

Total Cost: \$ 3080

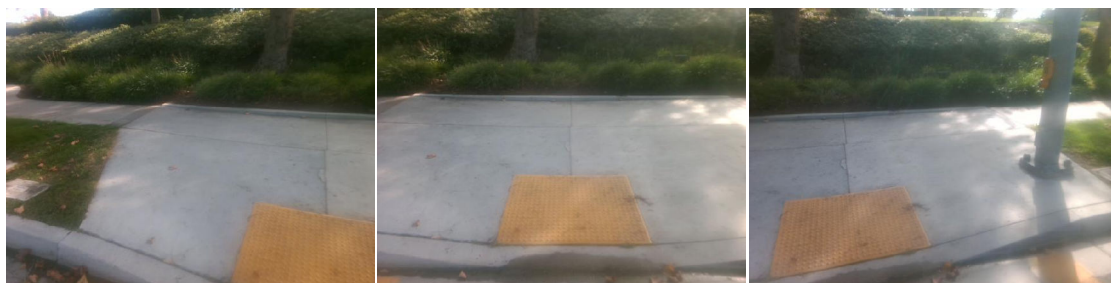
| Compliance | Description | Data | Compliance | Description | Data |
|---|---|---|---|---|---|
| Yes | Obstructions Present? | No | N/A | Utilities Present? | Yes |
| | Obstruction Dimensions | N/A | | Traffic Signal Pole | |
