# Access Compliance Report Public Rights-of-Way (Curb Ramps)

| Main Street: FLINTRIDGE_AVE | | Cross Street: SIENNA_PKWY | | Location: | N |
| ADA ID: RPRK211108123015 | Ramp Type: Type 4 - Parallel | Initial Pass/Fail: Fail | Overall Compliance: No | Severity Score: | 16 |

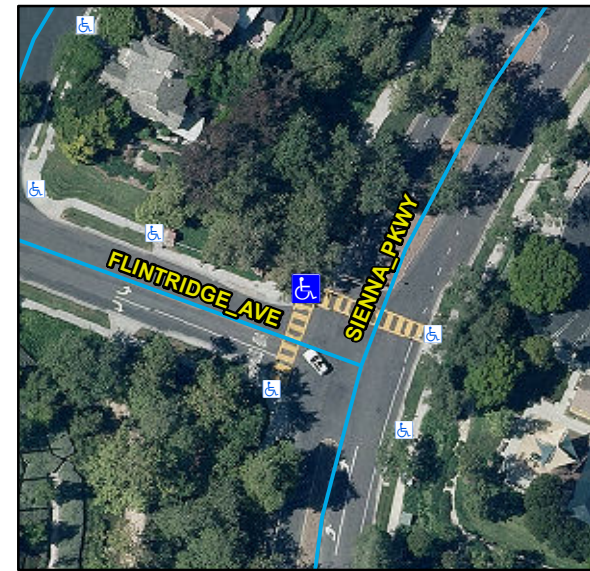
| Compliance | Description | Data | Compliance | Description | Data |
|---|---|---|---|---|---|
| Yes | Ramp Run Slope LT (%) | 0.7 | No | Ramp Run Slope RT (%) | 11 |
| No | Ramp Cross Slope LT (%) | 3.5 | No | Ramp Cross Slope RT (%) | 3.5 |

**Remove & Replace Curb Ramp With Two New Directional Ramps or Equivalent.**

**R204.3, R304.5.3, R304.3.2, STD 1115**
