# Access Compliance Report Public Rights-of-Way (Curb Ramps)

Main Street: SIENNA\_PKWY Cross Street: FLINTRIDGE\_AVE Location: W

ADA ID: RPRK211108123342 Ramp Type: Type 4 - Parallel Initial Pass/Fail: Fail Overall Compliance: No Severity Score: 16

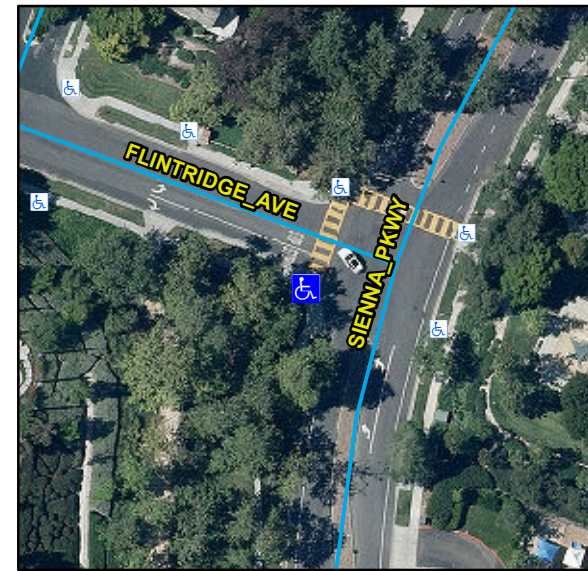
| Compliance | Description | Data | Compliance | Description | Data |
|---|---|---|---|---|---|
| Yes | Ramp Run Slope LT (%) | 4.3 | No | Ramp Run Slope RT (%) | 10.3 |
| No | Ramp Cross Slope LT (%) | 3.4 | Yes | Ramp Cross Slope RT (%) | 1.7 |

**Remove & Replace Curb Ramp With Two New Directional Ramps or Equivalent. Restripe Crosswalk.**
