# Access Compliance Report Public Rights-of-Way (Curb Ramps)

Main Street: PICKERING\_CIR Cross Street: FLINTRIDGE\_AVE Location: E

ADA ID: RPRK211108123604 Ramp Type: Type 4 - Parallel Initial Pass/Fail: Fail Overall Compliance: No Severity Score: 32

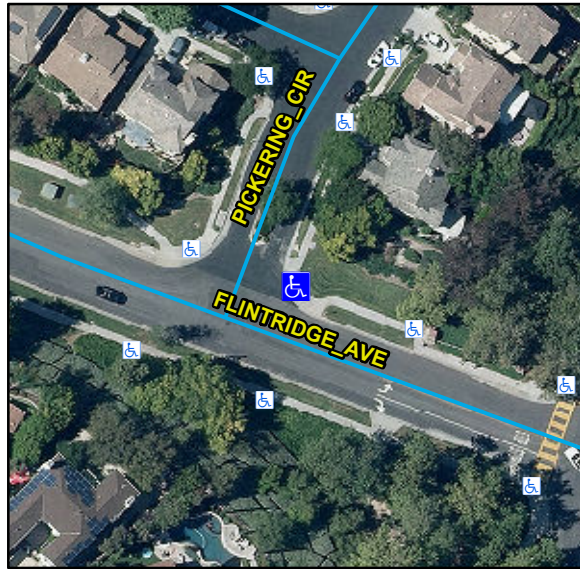
| Compliance | Description | Data | Compliance | Description | Data |
|---|---|---|---|---|---|
| No | Ramp Run Slope LT (%) | 13.7 | Yes | Ramp Run Slope RT (%) | 4.8 |

**Remove & Replace Curb Ramp With Two New Directional Ramps or Equivalent.**

**R204.3, R304.3.2, STD 1115**
