# Access Compliance Report Public Rights-of-Way (Curb Ramps)

Main Street: MINFORD\_RD Cross Street: PICKERING\_CIR Location: N

ADA ID: RPRK211108123904 Ramp Type: Type 4 - Parallel Initial Pass/Fail: Fail Overall Compliance: No Severity Score: 30

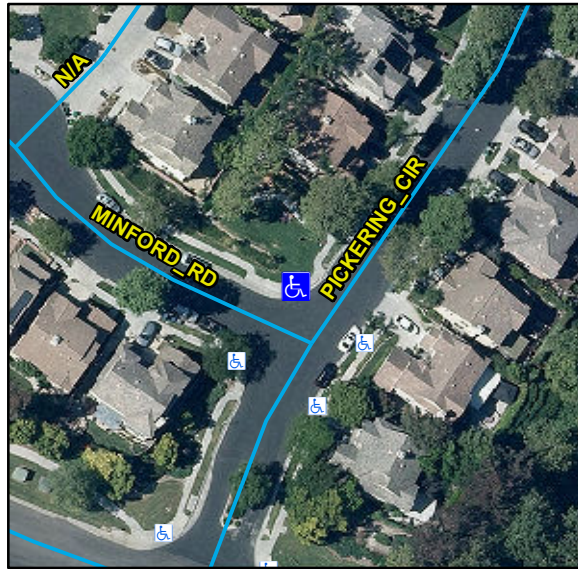
| Compliance | Description | Data | Compliance | Description | Data |
|---|---|---|---|---|---|
| Yes | Ramp Run Slope LT (%) | 0.4 | No | Ramp Run Slope RT (%) | 16.5 |
| N/A | Gutter Cross Slope (%) | N/A | No | Perpendicular Joint Present | No |

Remove & Replace Curb Ramp With Two New Directional Ramps or Equivalent.

R204.3, R304.3.2, STD 1115
