# Access Compliance Report Public Rights-of-Way (Curb Ramps)

| Main Street: PICKERING_CIR | | Cross Street: MINFORD_RD | | Location: | W |
| ADA ID: RPRK211108124036 | Ramp Type: Type 4 - Parallel | Initial Pass/Fail: Fail | Overall Compliance: No | Severity Score: | 32 |

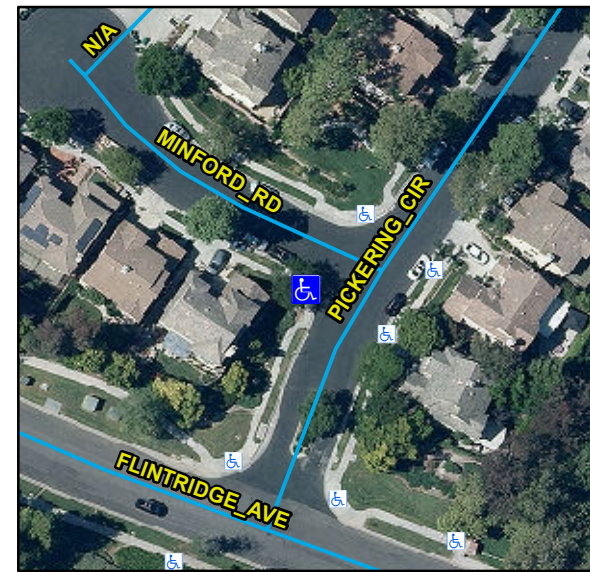
| Compliance | Description | Data | Compliance | Description | Data |
|---|---|---|---|---|---|
| Yes | Ramp Run Slope LT (%) | 1.7 | No | Ramp Run Slope RT (%) | 16.6 |
| No | Ramp Cross Slope LT (%) | 2.3 | No | Ramp Cross Slope RT (%) | 2.1 |

**Remove & Replace Curb Ramp With Two New Directional Ramps or Equivalent.**

**R204.3, R304.5.3, R304.3.2, STD 1115**

Total Cost: \$ 4000
