# Access Compliance Report Public Rights-of-Way (Curb Ramps)

Main Street: FLINTRIDGE\_AVE Cross Street: PICKERING\_CIR Location: N

ADA ID: RPRK211108124251 Ramp Type: Type 4 - Parallel Initial Pass/Fail: Fail Overall Compliance: No Severity Score: 32

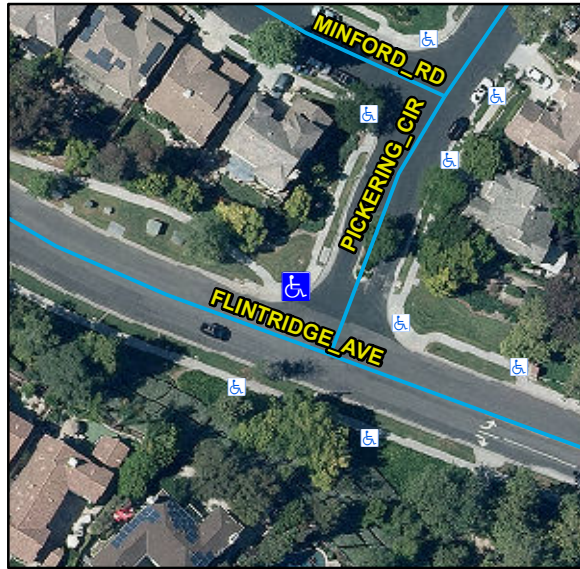
| Compliance | Description | Data | Compliance | Description | Data |
|---|---|---|---|---|---|
| No | Ramp Run Slope LT (%) | 14.2 | Yes | Ramp Run Slope RT (%) | 7.2 |
| Yes | Ramp Cross Slope LT (%) | 1.9 | No | Ramp Cross Slope RT (%) | 2.1 |

Remove & Replace Curb Ramp With Two New Directional Ramps or Equivalent.
