# Access Compliance Report Public Rights-of-Way (Curb Ramps)

| Main Street: FLINTRIDGE_AVE | | Cross Street: ROANOKE_DR | | Location: | NE |
| ADA ID: RPRK211108124523 | Ramp Type:Type 1 - Perpendicular | Initial Pass/Fail: Fail | Overall Compliance: No | Severity Score: | 30 |

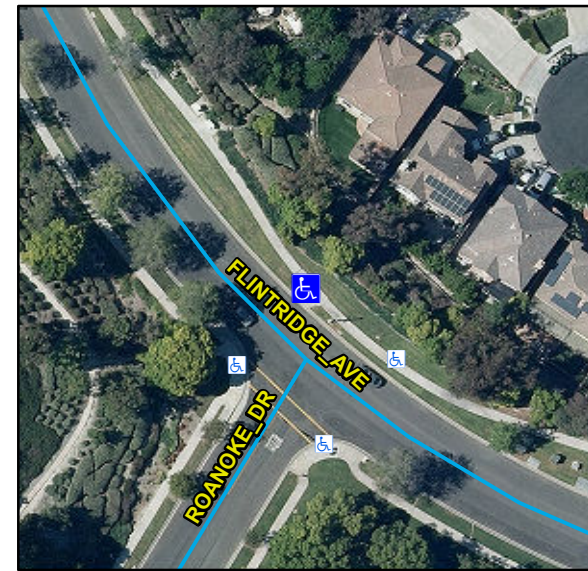
| Compliance | Description | Data | Compliance | Description | Data |
|---|---|---|---|---|---|
| No | Ramp Run Slope (%) | 8.4 | N/A | Flare Slope LT (%) | N/A |
| No | Ramp Cross Slope (%) | 6 | N/A | Flare Traversable LT | N/A |
| N/A | Gutter Ponding | N/A | No | Curb Slope | 9.8 |

**Remove & Replace Entire Ramp.**

**R304.2.2, R204.3, R304.5.3, STD 1115**

Total Cost: \$ 3080
