# Access Compliance Report Public Rights-of-Way (Curb Ramps)

| Main Street: ROANOKE_DR | | Cross Street: FLINTRIDGE_AVE | | Location: | W |
| ADA ID: RPRK211108124717 | Ramp Type: Type 4 - Parallel | Initial Pass/Fail: Fail | Overall Compliance: No | Severity Score: | 16 |

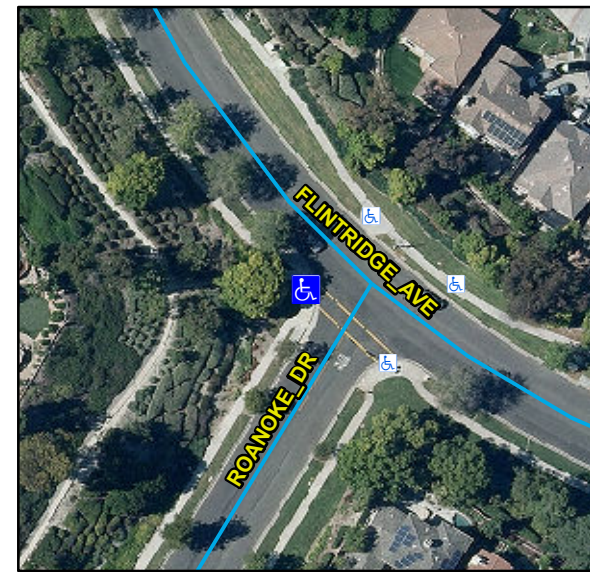
| Compliance | Description | Data | Compliance | Description | Data |
|---|---|---|---|---|---|
| Yes | Ramp Run Slope LT (%) | 0.9 | No | Ramp Run Slope RT (%) | 11.5 |
| No | Ramp Cross Slope LT (%) | 2.6 | Yes | Ramp Cross Slope RT (%) | 1.5 |

**Remove & Replace Curb Ramp With Two New Directional Ramps or Equivalent.**

**R204.3, R304.5.3, R304.3.2, STD 1115**
