# Access Compliance Report Public Rights-of-Way (Curb Ramps)

| Main Street: FLINTRIDGE_AVE | | Cross Street: ROANOKE_DR | | Location: | S |
| ADA ID: RPRK211108124919 | Ramp Type: Type 4 - Parallel | Initial Pass/Fail: Fail | Overall Compliance: No | Severity Score: | 16 |

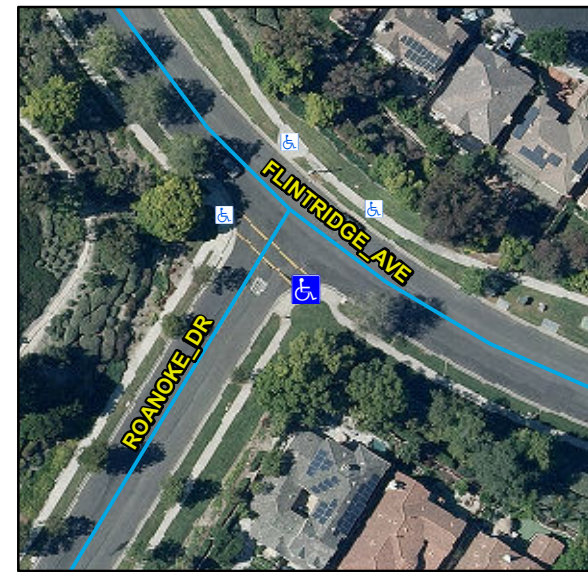
| Compliance | Description | Data | Compliance | Description | Data |
|---|---|---|---|---|---|
| Yes | Ramp Run Slope LT (%) | 3.7 | No | Ramp Run Slope RT (%) | 11.8 |

**Remove & Replace Curb Ramp With Two New Directional Ramps or Equivalent.**

**R204.3, R304.3.2, STD 1115**
