# Access Compliance Report Public Rights-of-Way (Curb Ramps)

Main Street: MAIN\_ST Cross Street: WINDMILL\_AVE Location: NE

ADA ID: RPRK211109113828 Ramp Type: Type 4 - Parallel Initial Pass/Fail: Fail Overall Compliance: No Severity Score: 16

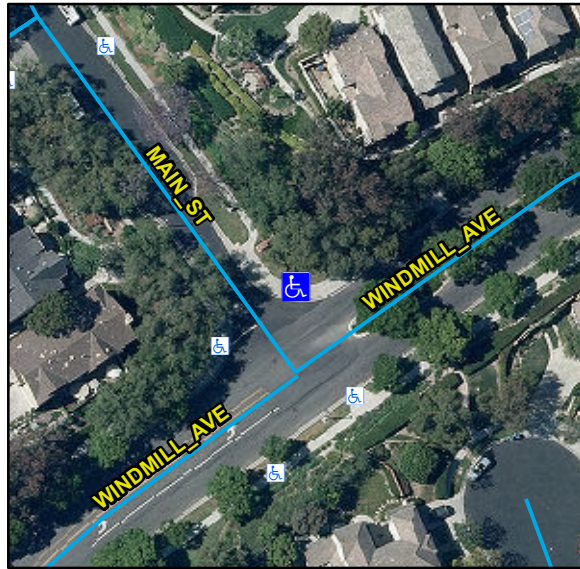
| Compliance | Description | Data | Compliance | Description | Data |
|---|---|---|---|---|---|
| Yes | Ramp Run Slope LT (%) | 5.6 | No | Ramp Run Slope RT (%) | 9.7 |
| No | Ramp Cross Slope LT (%) | 4.5 | No | Ramp Cross Slope RT (%) | 2.8 |

**Remove & Replace Curb Ramp With Two New Directional Ramps or Equivalent.**

**R204.3, R304.5.3, R304.3.2, STD 1115**
