# Access Compliance Report Public Rights-of-Way (Curb Ramps)

Main Street: WINDMILL\_AVE Cross Street: MAIN\_ST Location: NW

ADA ID: RPRK211109114242 Ramp Type: Type 4 - Parallel Initial Pass/Fail: Fail Overall Compliance: No Severity Score: 16

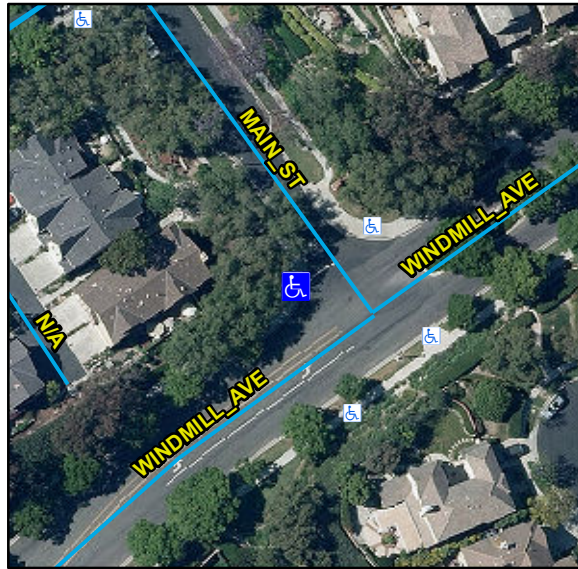
| Compliance | Description | Data | Compliance | Description | Data |
|---|---|---|---|---|---|
| Yes | Ramp Run Slope LT (%) | 4.8 | No | Ramp Run Slope RT (%) | 11.1 |
| No | Ramp Cross Slope LT (%) | 3.7 | No | Ramp Cross Slope RT (%) | 2.5 |

Remove & Replace Curb Ramp With Two New Directional Ramps or Equivalent.

R204.3, R304.5.3, R304.3.2, STD 1115
