# Access Compliance Report Public Rights-of-Way (Curb Ramps)

Main Street: WINDMILL\_AVE Cross Street: SNAPDRAGON\_ST Location: N

ADA ID: RPRK211109114604 Ramp Type: Type 1 - Perpendicular Initial Pass/Fail: Fail Overall Compliance: No Severity Score: 60

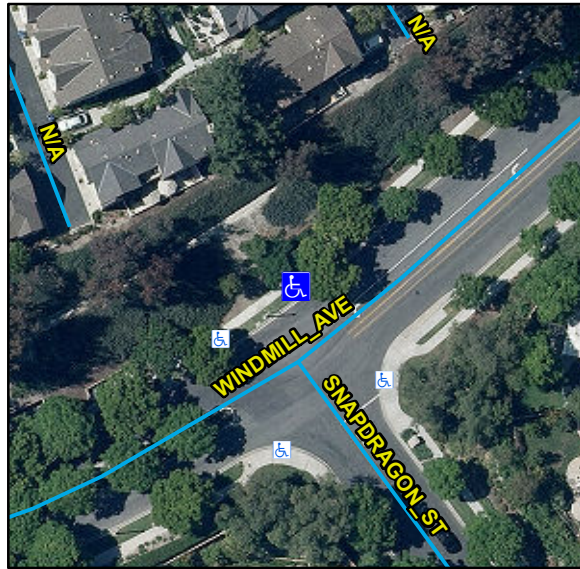
| Compliance | Description | Data | Compliance | Description | Data |
|---|---|---|---|---|---|
| No | Ramp Run Slope (%) | 13.2 | N/A | Flare Slope LT (%) | N/A |
| No | Ramp Cross Slope (%) | 9.1 | N/A | Flare Traversable LT | N/A |

Remove & Replace Entire Ramp.
