# Access Compliance Report Public Rights-of-Way (Curb Ramps)

Main Street: WINDMILL\_AVE Cross Street: SIENNA\_PKWY Location: E

ADA ID: RPRK211109115116 Ramp Type: Type 1 - Perpendicular Initial Pass/Fail: Fail Overall Compliance: No Severity Score: 16

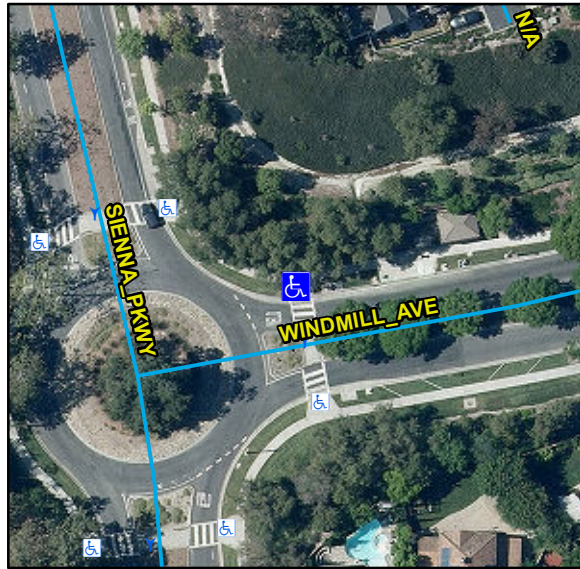
| Compliance | Description | Data | Compliance | Description | Data |
|---|---|---|---|---|---|
| No | Ramp Run Slope (%) | 9.4 | N/A | Flare Slope LT (%) | N/A |
| No | Ramp Cross Slope (%) | 3.9 | N/A | Flare Traversable LT | N/A |

Remove & Replace Entire Ramp.
